**RESEARCH  
REPORT  
NO.90-1**

# **Membrane and Flashing Condition Indexes for Built-Up Roofs Volume II: Inspection and Distress Manual**

**by  
Mohamed Y. Shahin  
David M. Bailey  
Donald E. Brotherson**

**Building Research Council, University of Illinois, Champaign, IL  
In cooperation with the US Army Corps of Engineers  
Construction Engineering Research Laboratory**

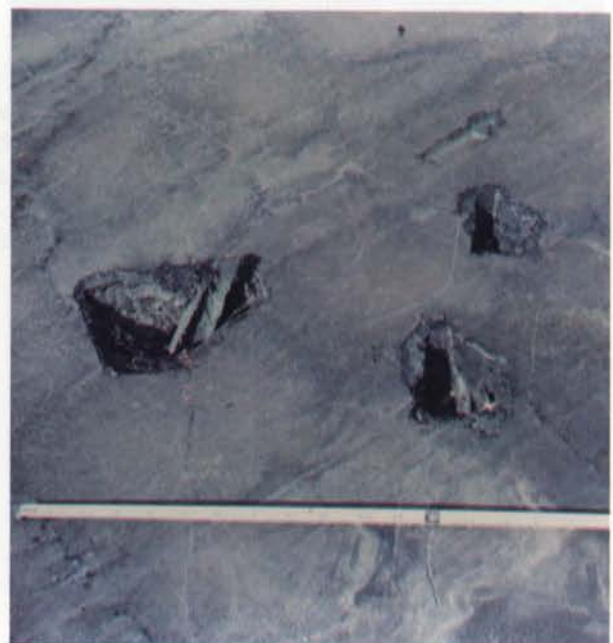
HL2 Holes  
<High Severity>  
Holes in smooth surfaced  
roof

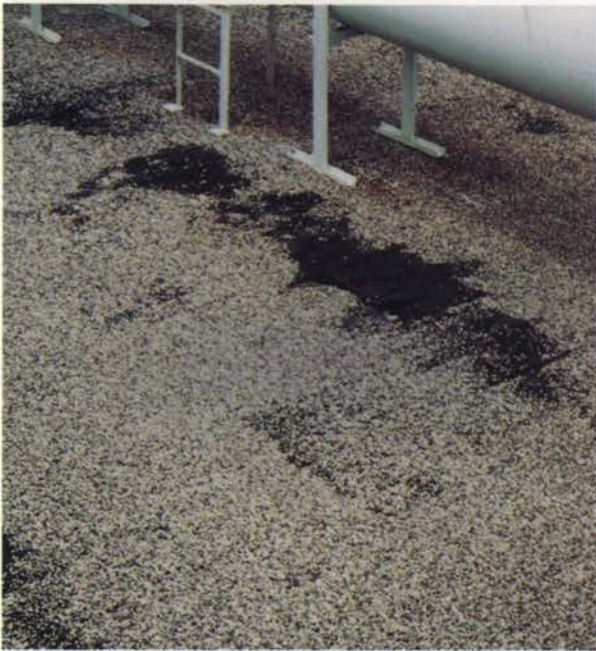
SR1 Surface Deterioration  
 <Low Severity>  
 Gravel is loose and easily displaced  
 by wind; imbedment of gravel is minimal  
 <Medium Severity>  
 Bare areas

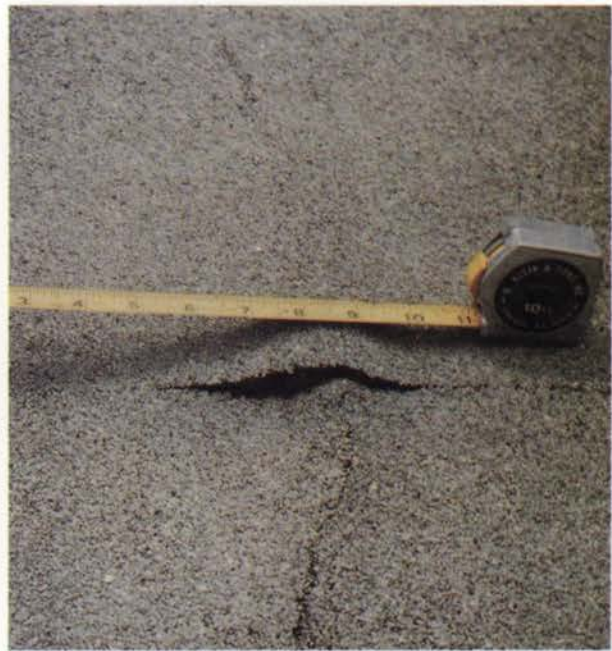
SR2 Surface Deterioration  
 <Low Severity>  
 There are open edge laps or  
 fishmouths

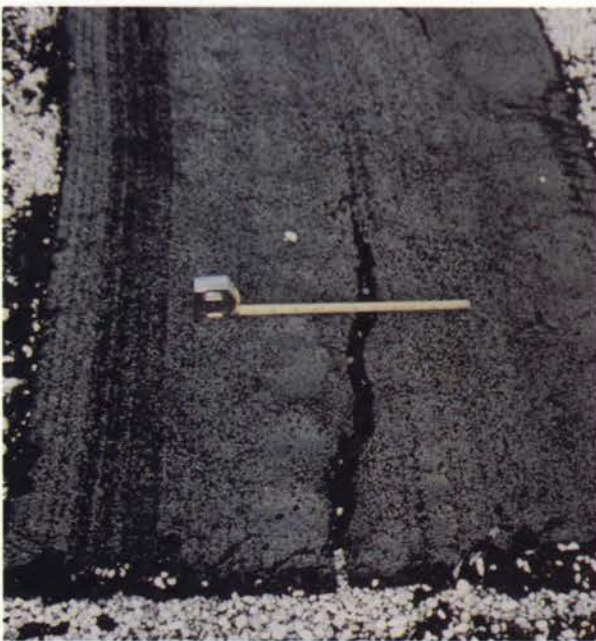
SR3 Surface Deterioration  
 <Low Severity>  
 Walkways are cracked or blistered

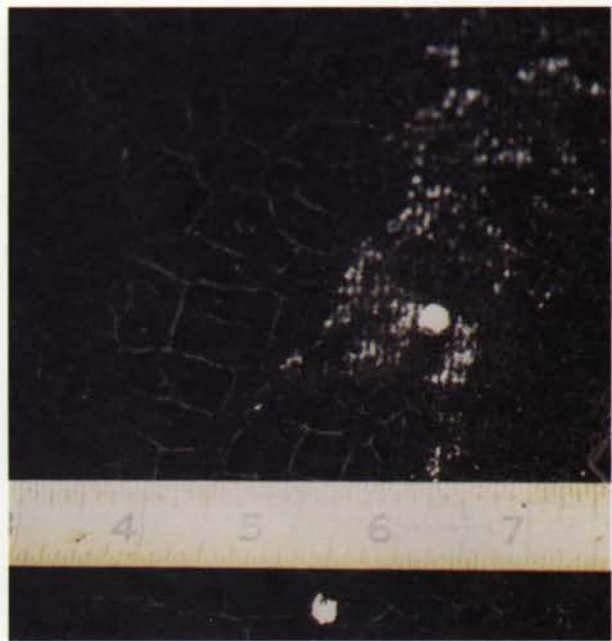
SR4 Surface Deterioration  
 <Low Severity>  
 Hairline alligator cracking of the  
 surface is evident

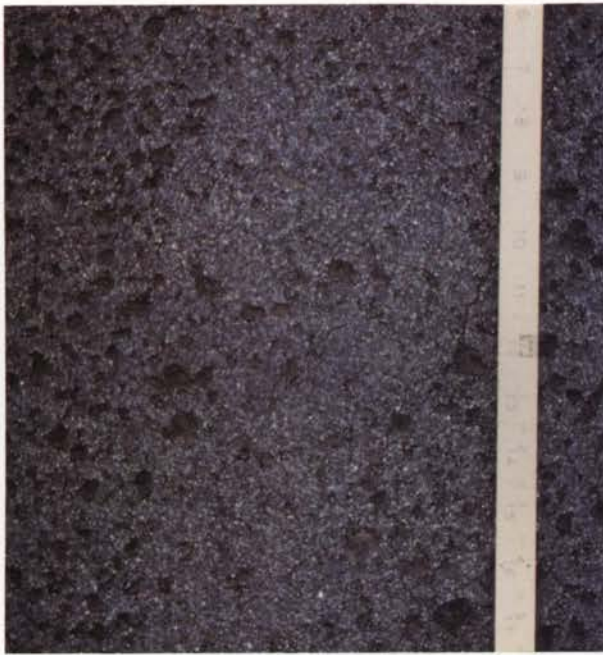
SR5 Surface Deterioration  
 <Medium Severity>  
 Granule surface on cap sheet is eroded

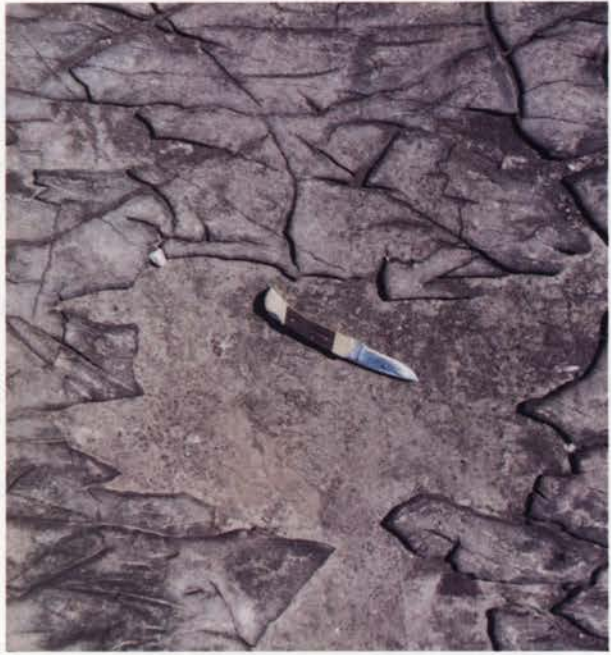
SR6 Surface Deterioration  
 <Medium Severity>  
 Loss of surface coating on smooth surface roof

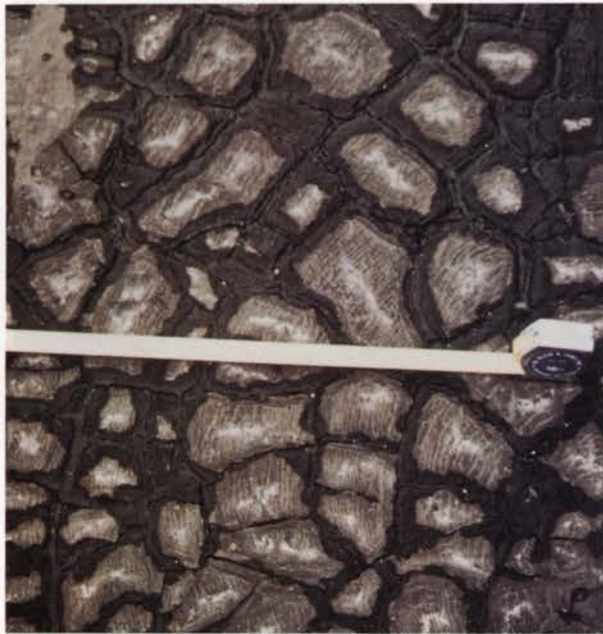
SR7 Surface Deterioration  
 <Medium Severity>  
 Alligator cracking of the surface extends down to the felt

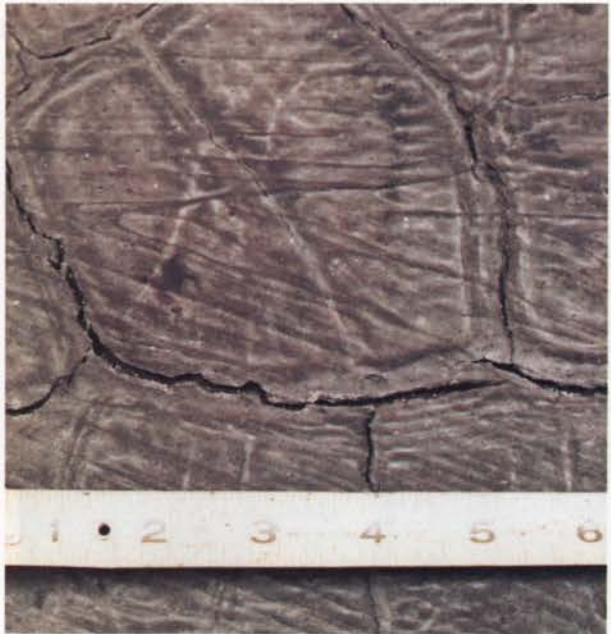
SR8 Surface Deterioration  
 <Medium Severity>  
 Alligator cracking of the surface extends down to the felt

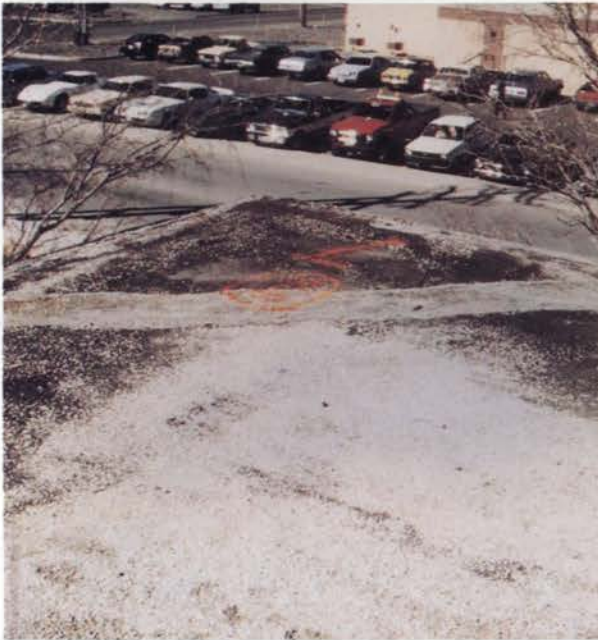
SR9 Surface Deterioration  
 <Medium Severity>  
 Gravel surfacing shows erosion from  
 wind coming over corner of building

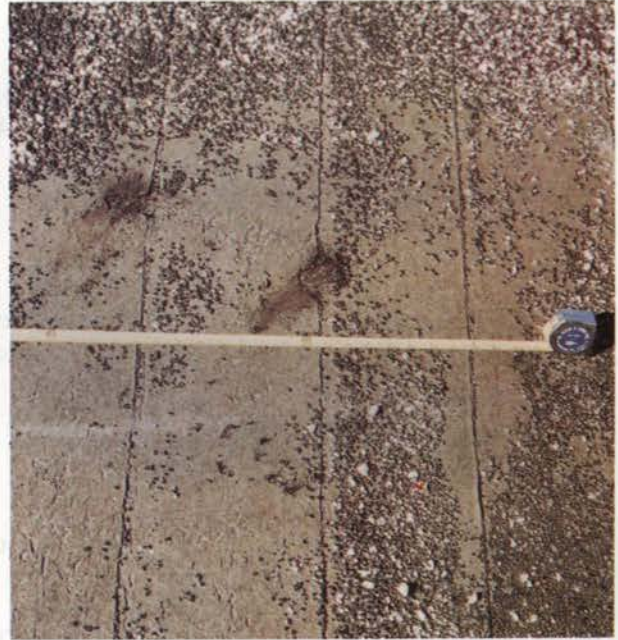
SR10 Surface Deterioration  
 <High Severity>  
 Gravel surfacing is gone and felts  
 are starting to show wear

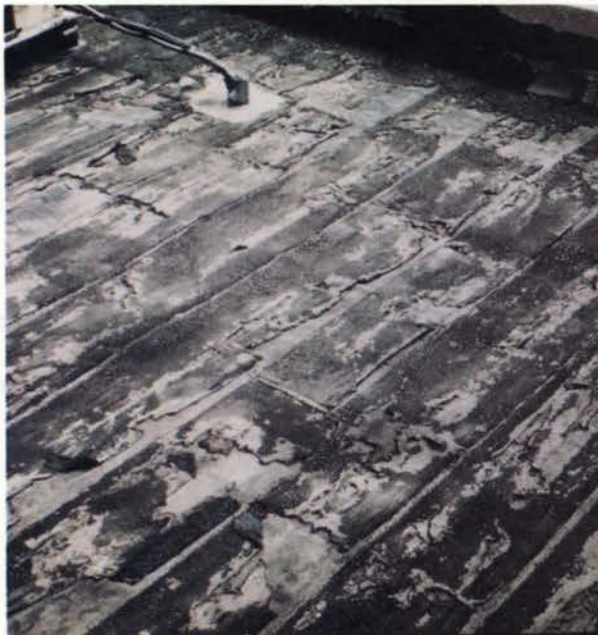
SR11 Surface Deterioration  
 <High Severity>  
 Smooth surface membrane is  
 deteriorated

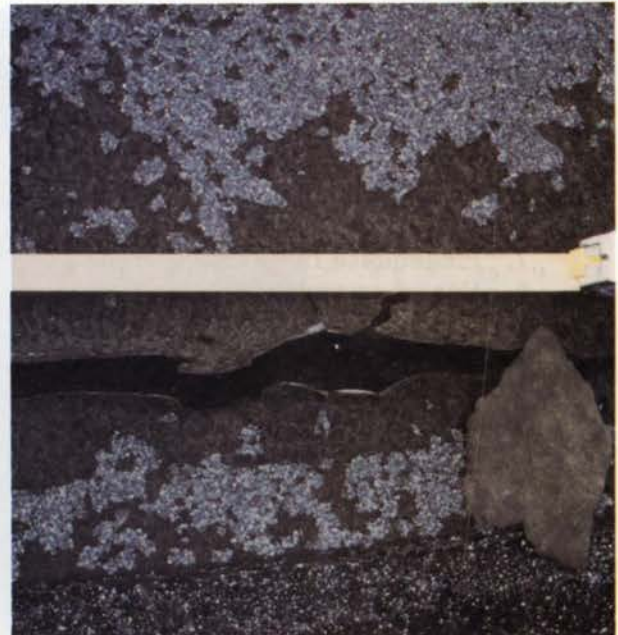
SR12 Surface Deterioration  
 <High Severity>  
 Cap sheet is completely worn and  
 felt is torn or broken

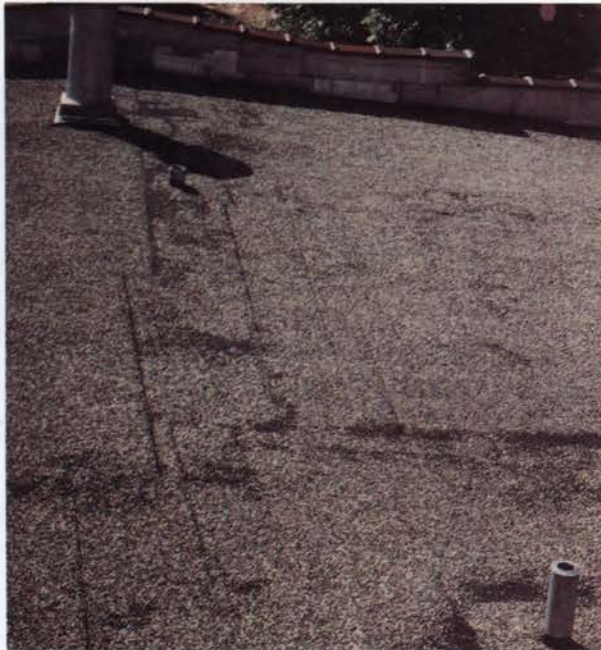
SL1 Slippage  
<Low Severity>  
Slippage lines can be seen in the  
roof surface

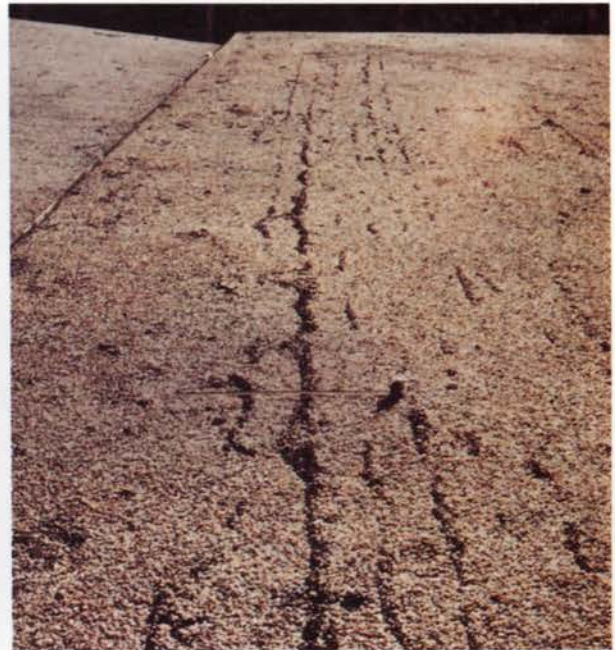
SL2 Slippage  
<High Severity>  
Slippage is greater than 2 in.

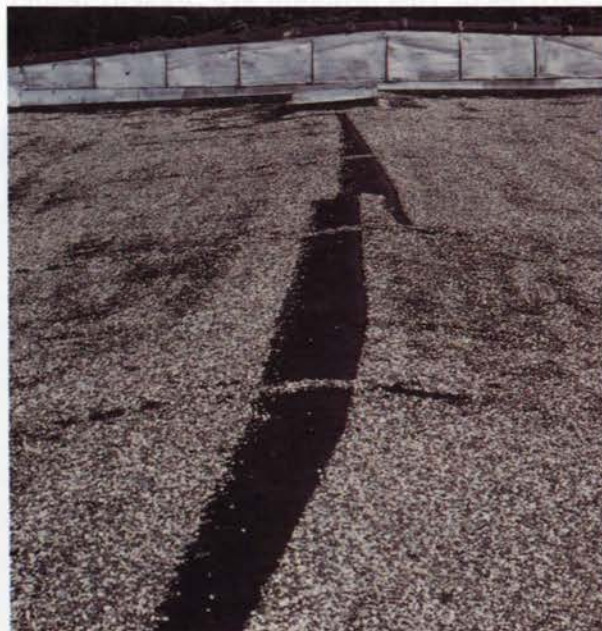
SL3 Slippage  
<High Severity>  
Slippage is evident in surface and  
is greater than 2 in.

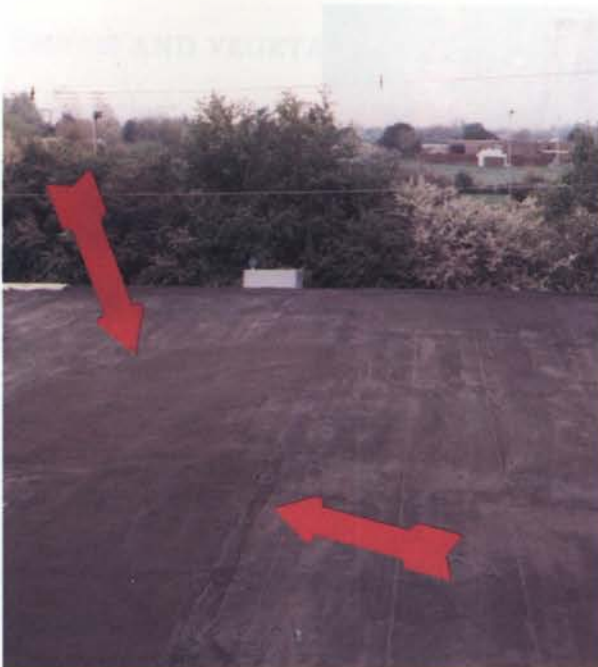
PA1 Patching  
 <Low Severity>  
 Patching is evident in smooth surfaced roof.

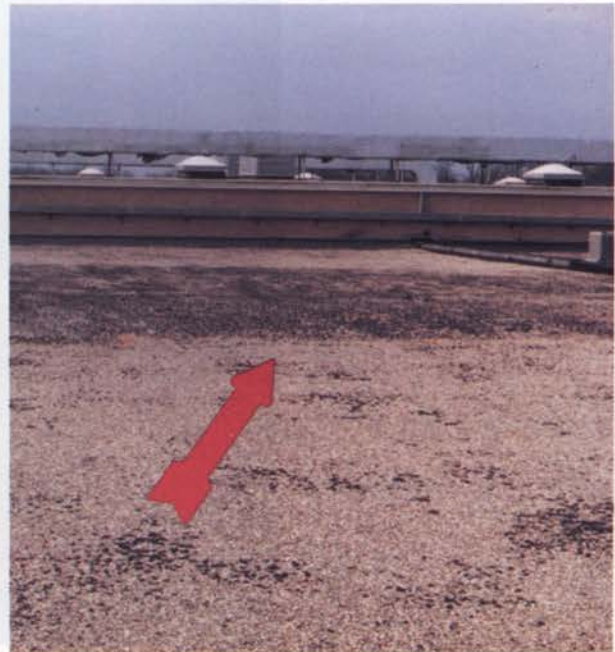
PA2 Patching  
 <Low Severity>  
 Patching is evident in gravel surfaced roof

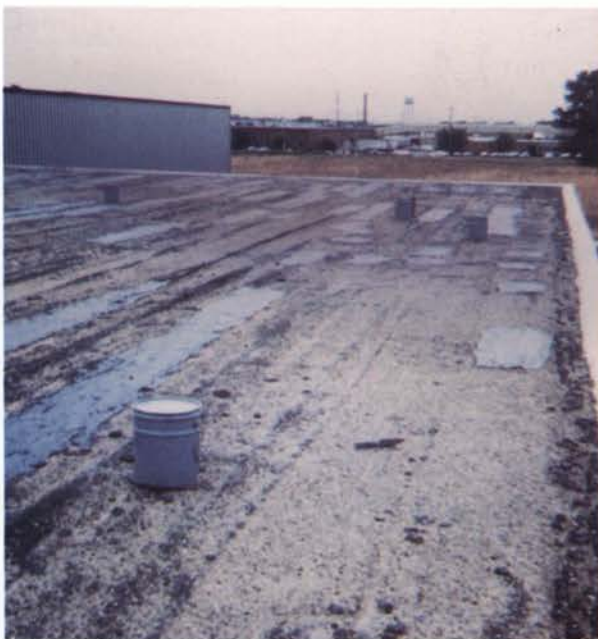
PA3 Patching  
 <Medium Severity>  
 Patching material is not the same as the original roof

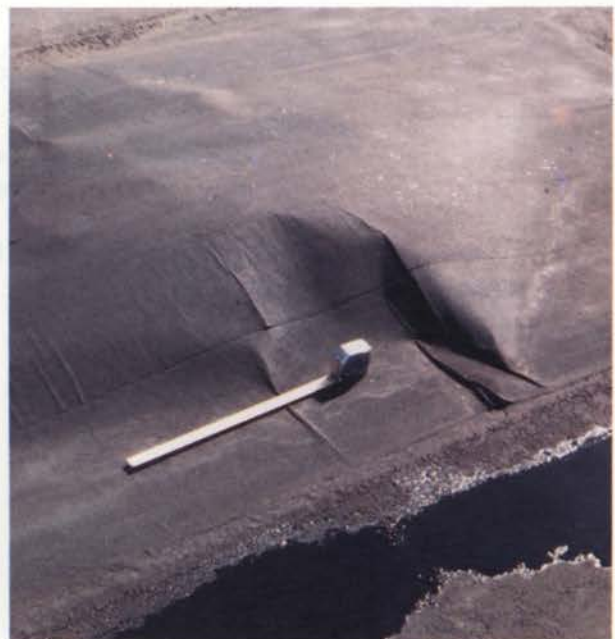
PA4 Patching  
 <High Severity>  
 Patched area has a high severity blister

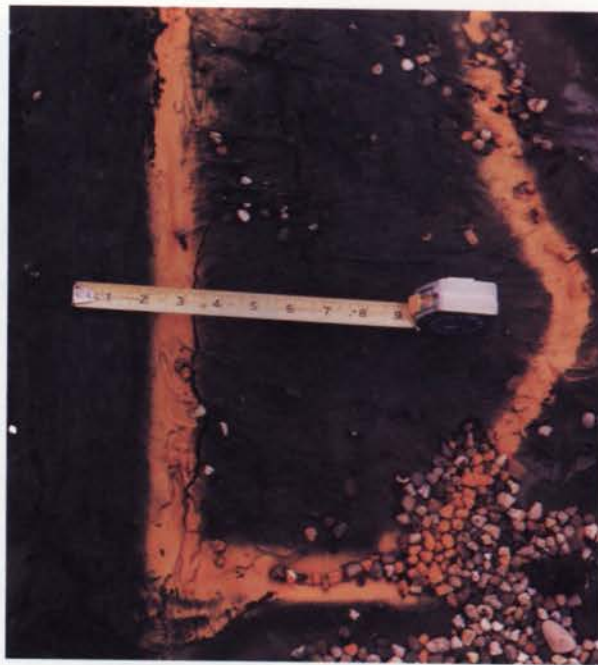
PA5 Patching  
 <High Severity>  
 Patched area has a split

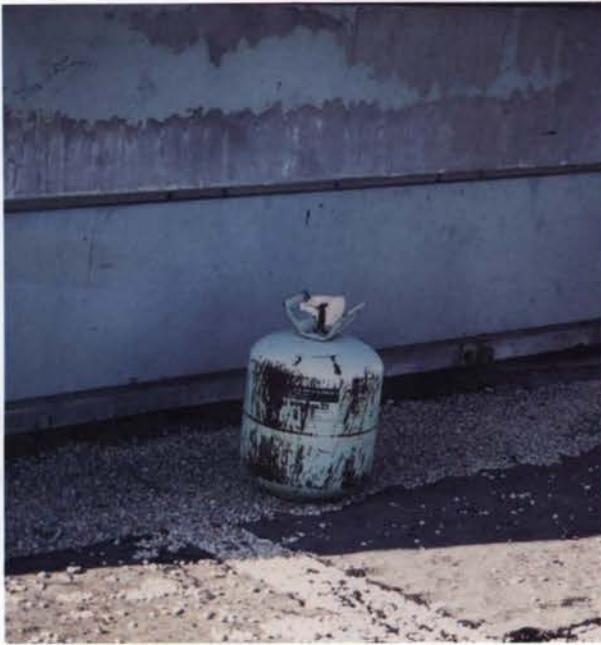
DV1 Debris and Vegetation  
Freon container left on roof;  
inspector should remove

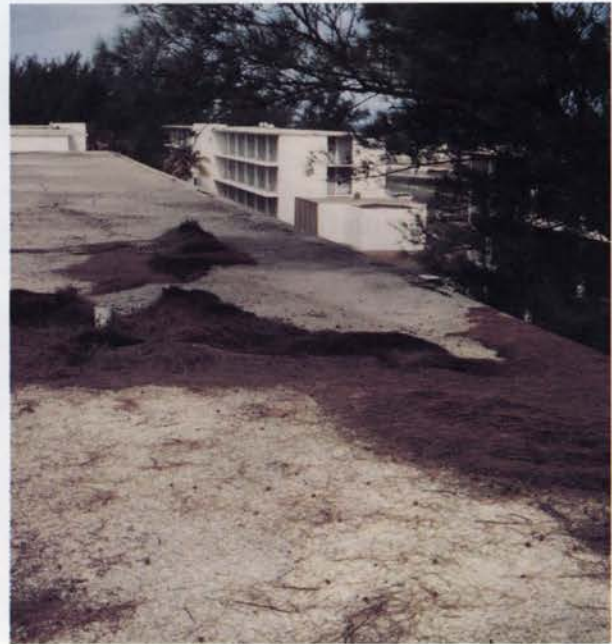
DV2 Debris and Vegetation  
<Medium Severity>  
Accumulation of tree needles  
on roof

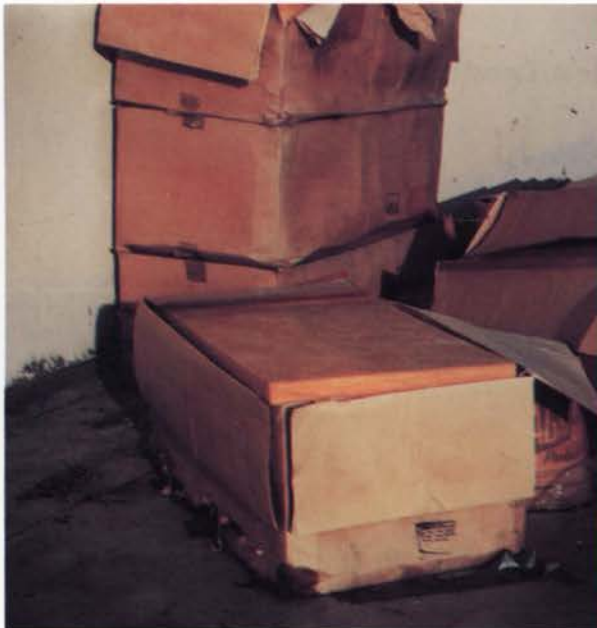
DV3 Debris and Vegetation  
<Medium Severity>  
Boxes of roof insulation left on roof

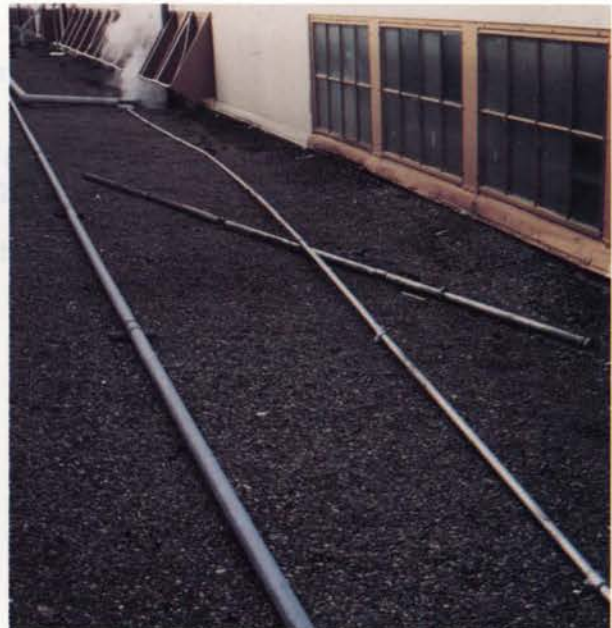
DV4 Debris and Vegetation  
<Medium Severity>  
Conduit and piping left on roof

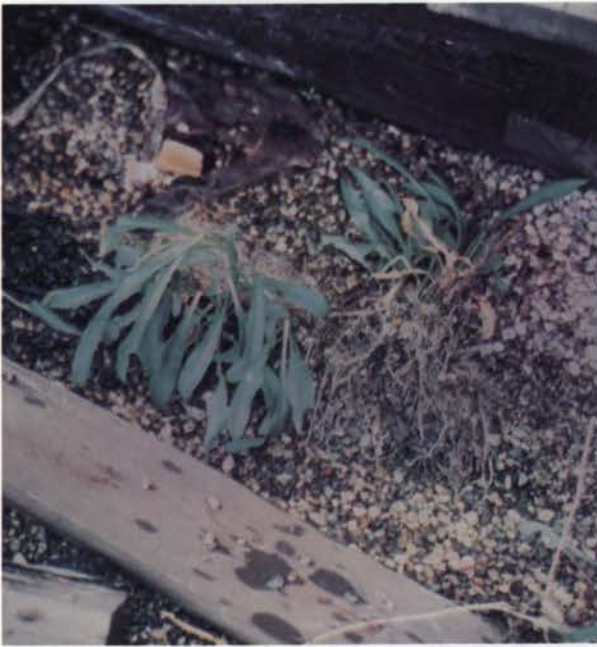
DV5 Debris and Vegetation  
 <Medium Severity>  
 Grass growing on roof

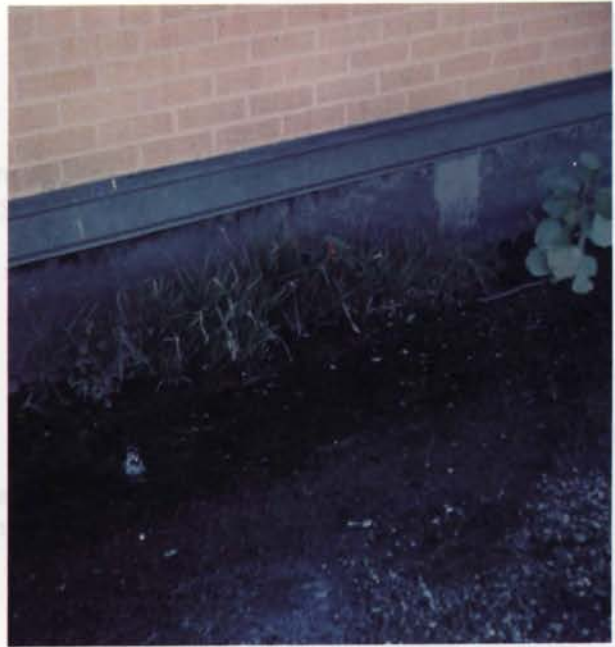
DV6 Debris and Vegetation  
 <Medium Severity>  
 Vegetation growing on roof

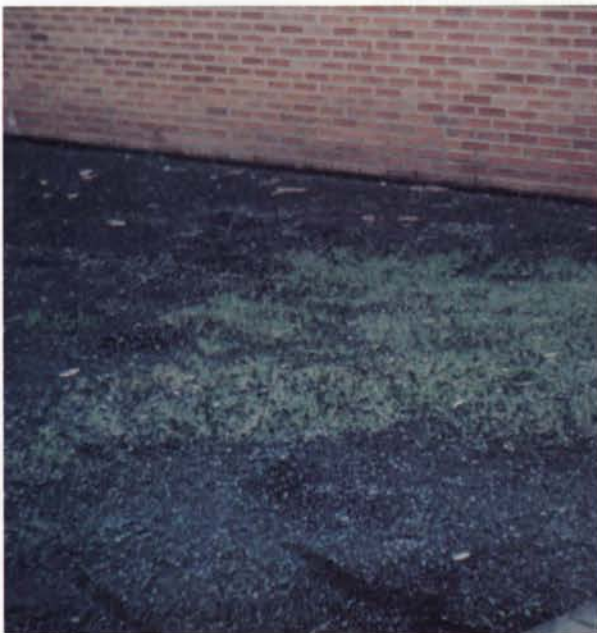
DV7 Debris and Vegetation  
 <Medium Severity>  
 Lawn growing on roof

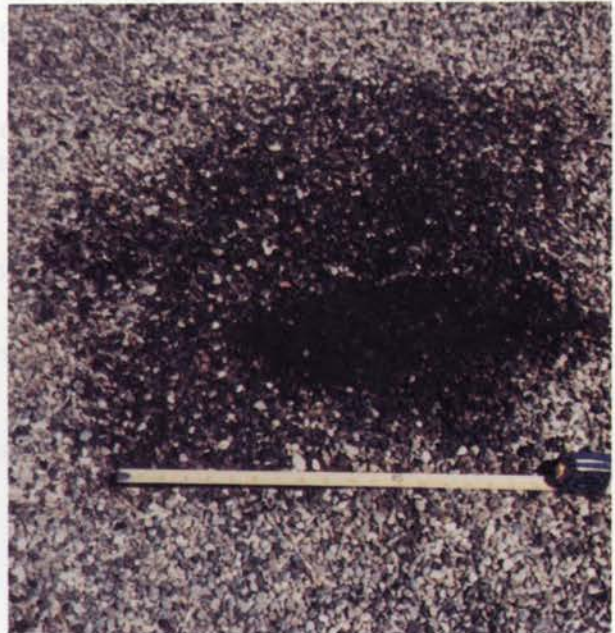
DV8 Debris and Vegetation  
 <High Severity>  
 Degradation of membrane due to  
 oil or solvent drippage

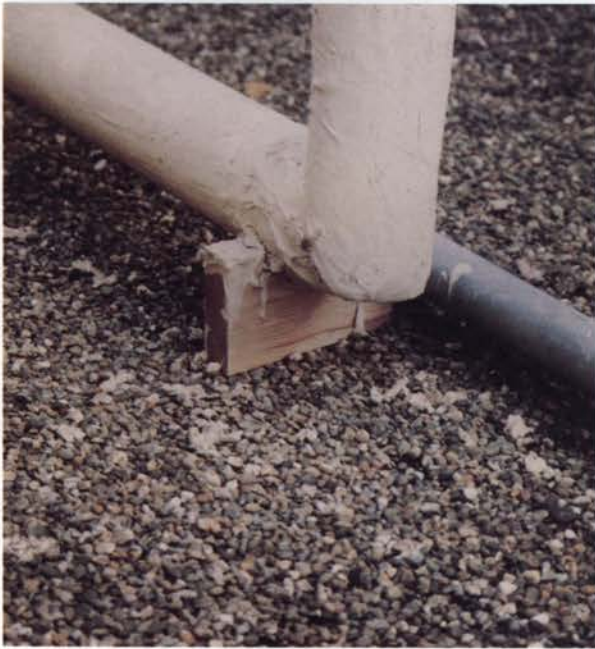
EQ1 Improper Equipment Supports  
 <Low Severity>  
 Pipe supported by wood block

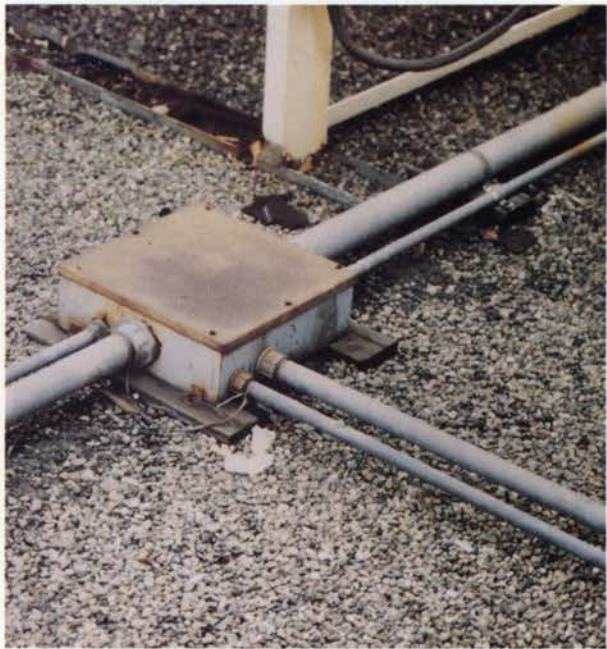
EQ2 Improper Equipment Supports  
 <Low Severity>  
 Conduit supported by wood blocks

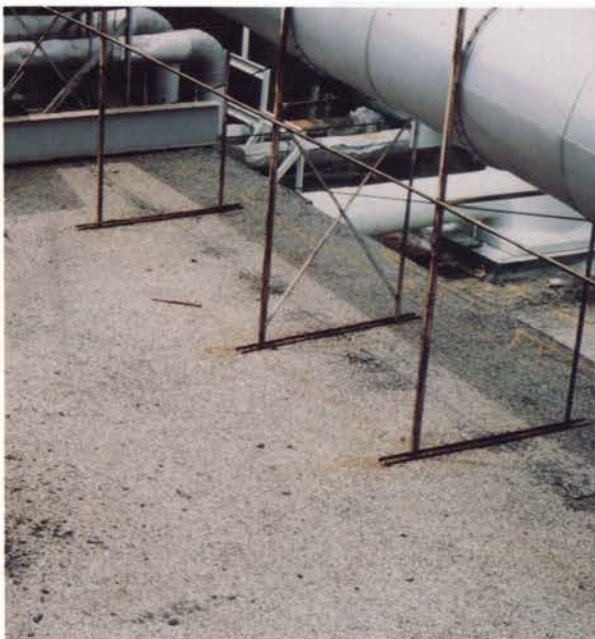
EQ3 Improper Equipment Supports  
 <Low Severity>  
 Ductwork supported on steel channels  
 which rest on the membrane, unflashed

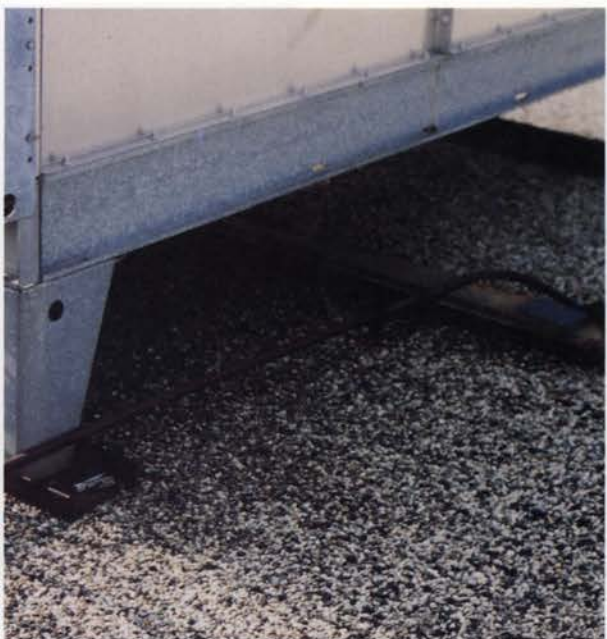
EQ4 Improper Equipment Supports  
 <Low Severity>  
 Large air-conditioning unit  
 supported on unflashed steel

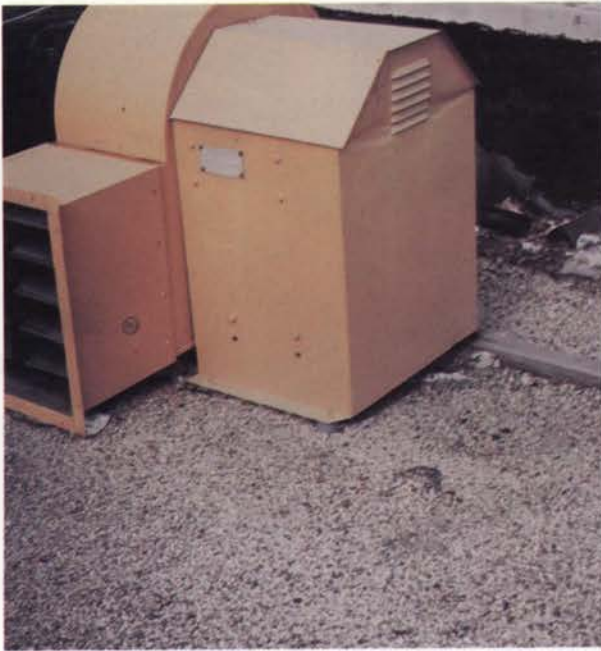
EQ5 Improper Equipment Supports  
<Medium Severity>  
Air handling equipment installed  
directly on the roof surface

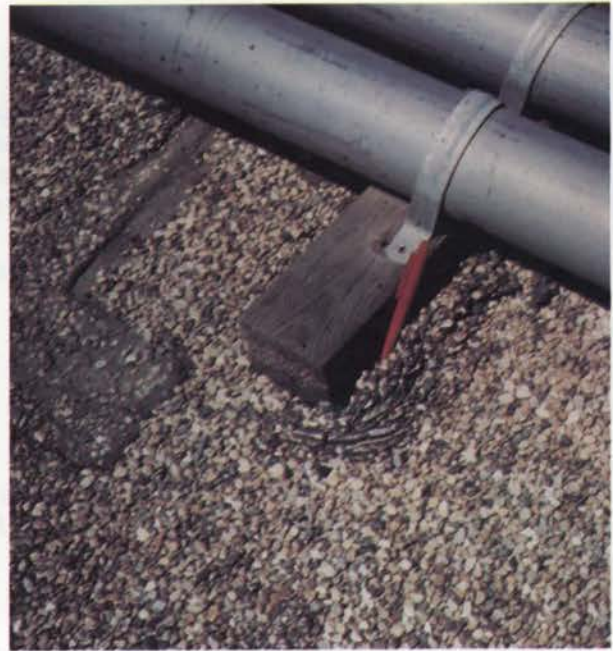
EQ6 Improper Equipment Supports  
<High Severity>  
Blocks supporting piping have  
moved, tearing the roof membrane

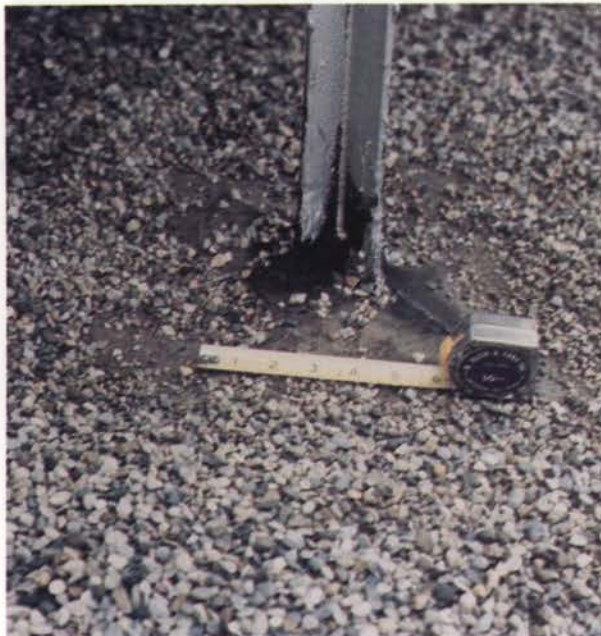
EQ7 Improper Equipment Supports  
<High Severity>  
Angle leg set on roof without  
flashing

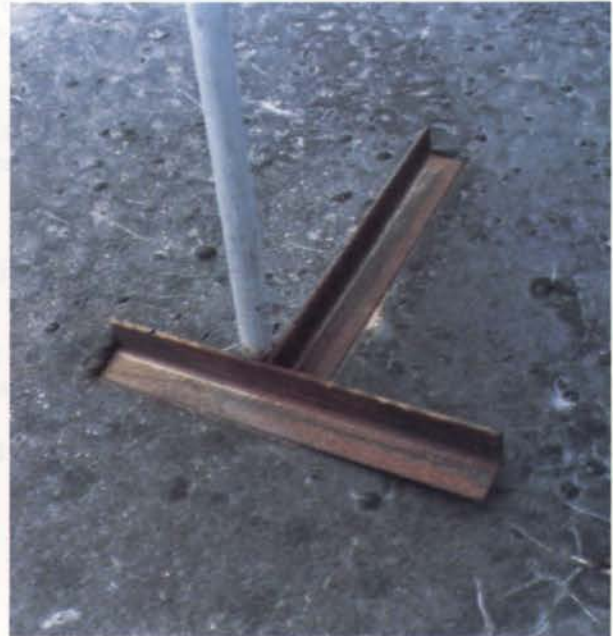
EQ8 Improper Equipment Supports  
<High Severity>  
Equipment support has damaged  
membrane

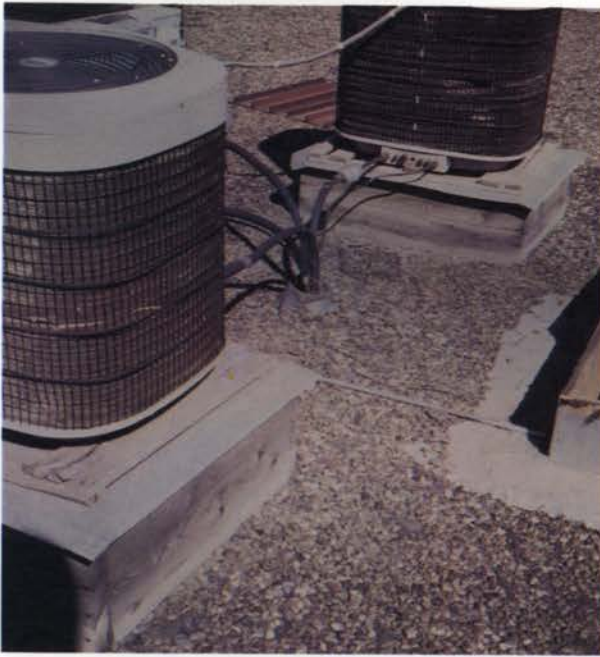
EQ9 Improper Equipment Supports  
 <High Severity>  
 Improper A/C support and pipe  
 penetration

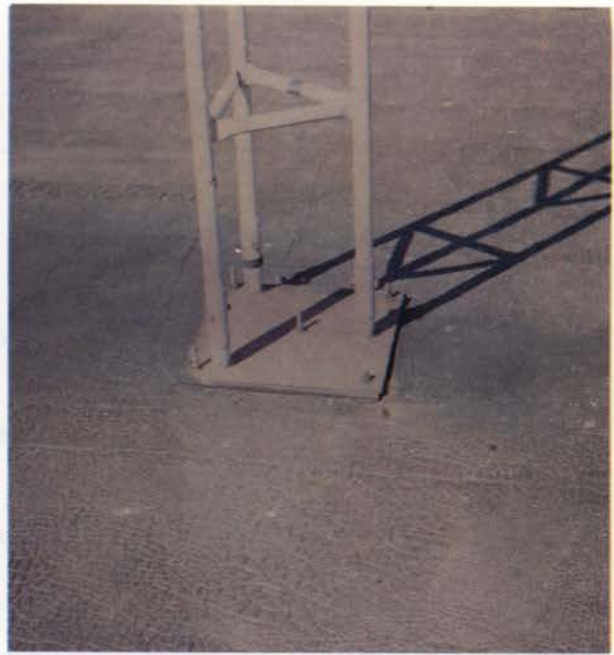
EQ10 Improper Equipment Supports  
 <High Severity>  
 Base for antenna has not been  
 placed on a flashed curb.  
 Bolts penetrate membrane

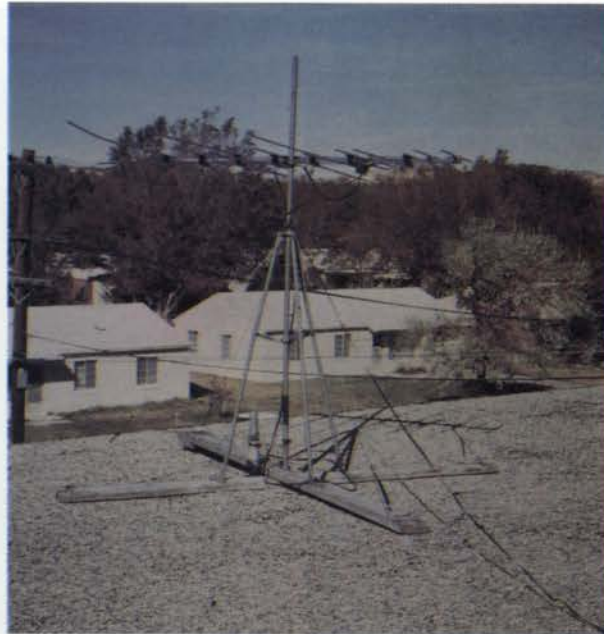
EQ11 Improper Equipment Supports  
 <High Severity>  
 Antenna base is nailed to roof

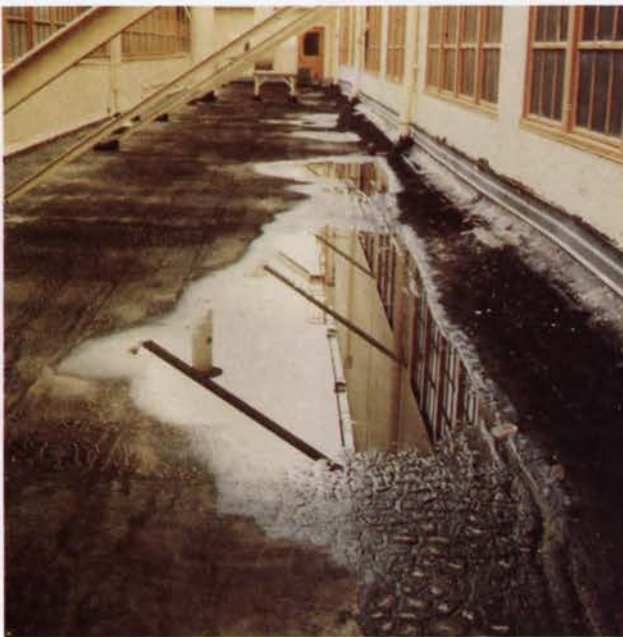
PD1 Ponding  
<Low Severity>  
Ponding is occurring between  
drains

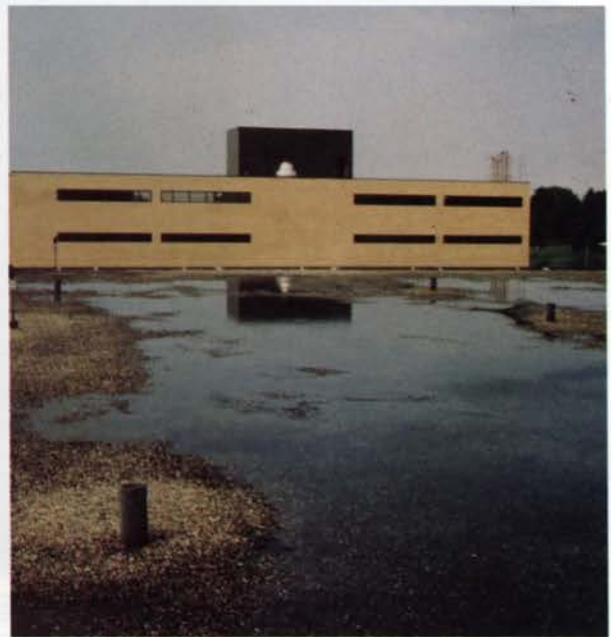
PD2 Ponding  
<Low Severity>  
Ponding on "dead-flat" roof

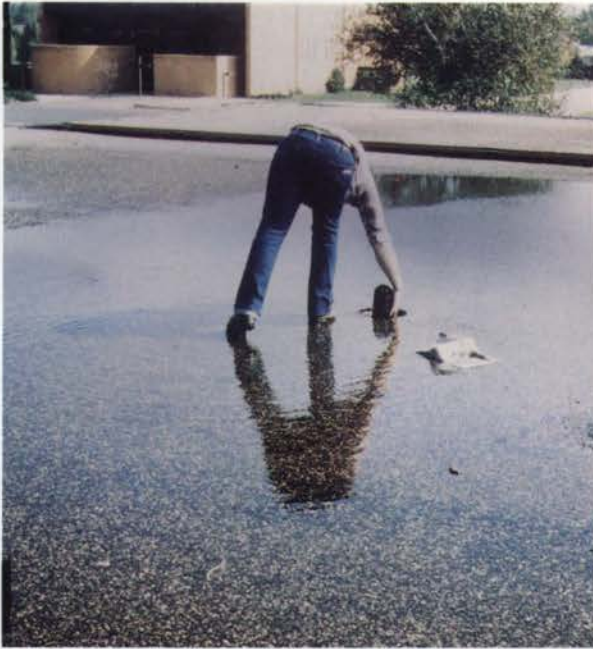
PD3 Ponding  
 <Low Severity>  
 Drain is blocked. Clearing of drain by the inspector will eliminate the distress

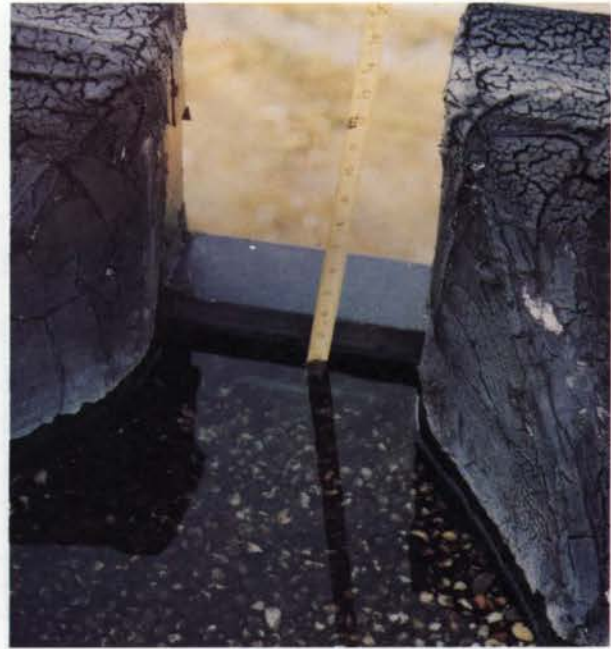
PD4 Ponding  
 <Low Severity>  
 Scupper edge is too high and blocks drainage

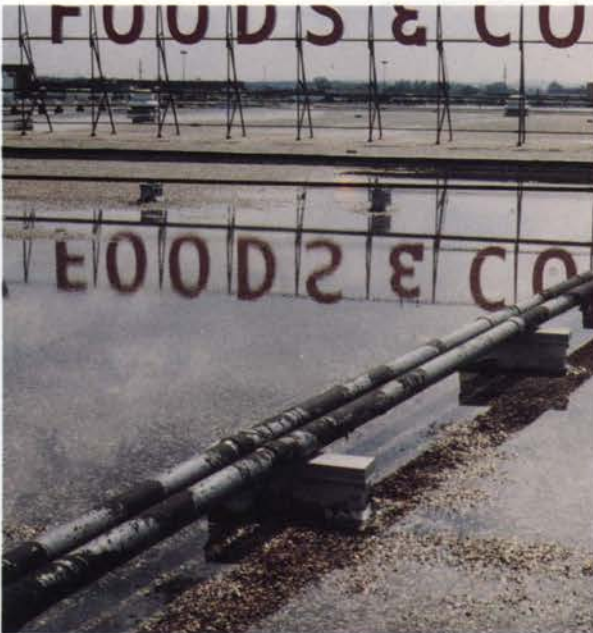
PD5 Ponding  
 <Low Severity>  
 General ponding due to poor drain locations

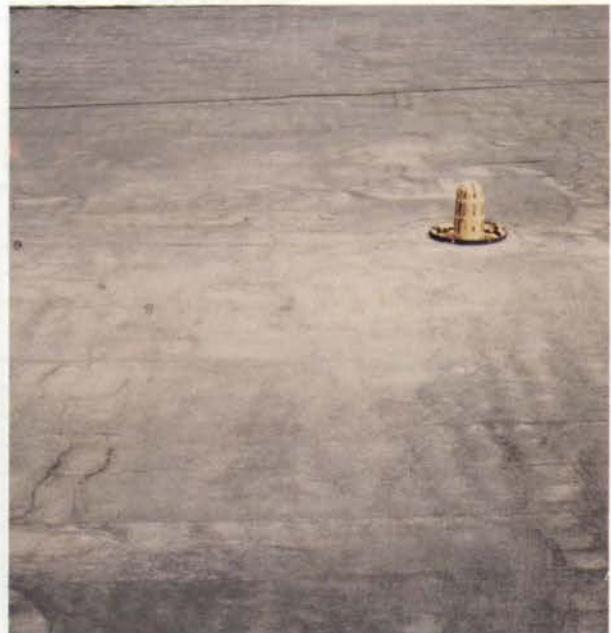
PD6 Ponding  
 <Low Severity>  
 Dirt accumulation on roof indicating that water ponds near the drain

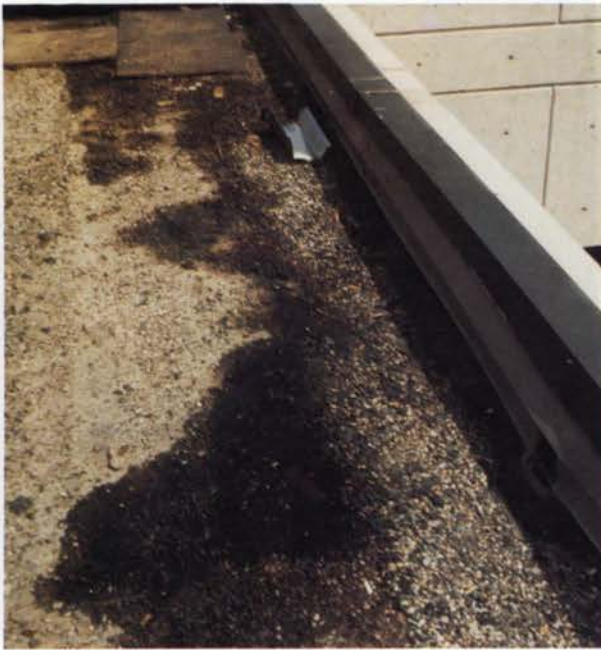
PD7 Ponding  
 <Low Severity>  
 Debris--indication of ponding

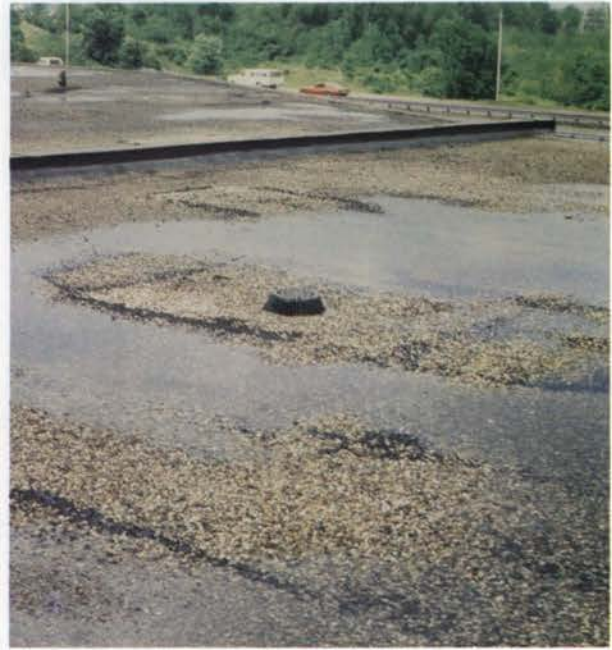
PD8 Ponding  
 <Low Severity>  
 Drain is placed too high

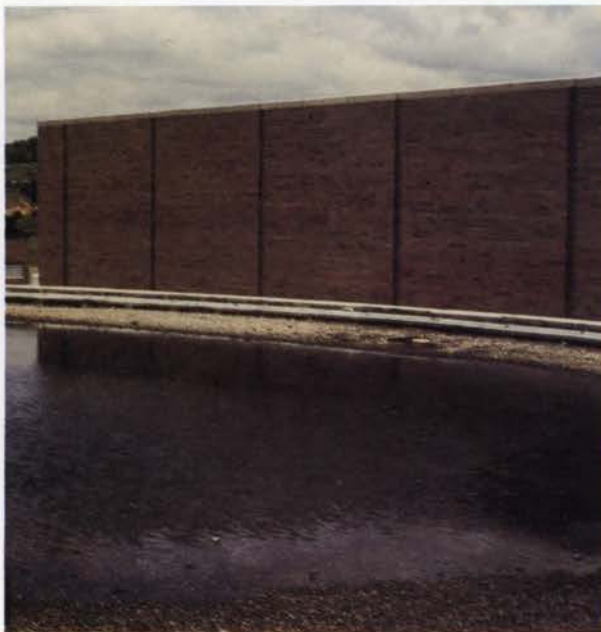
PD9 Ponding  
 <Low Severity>  
 Ponding on roof

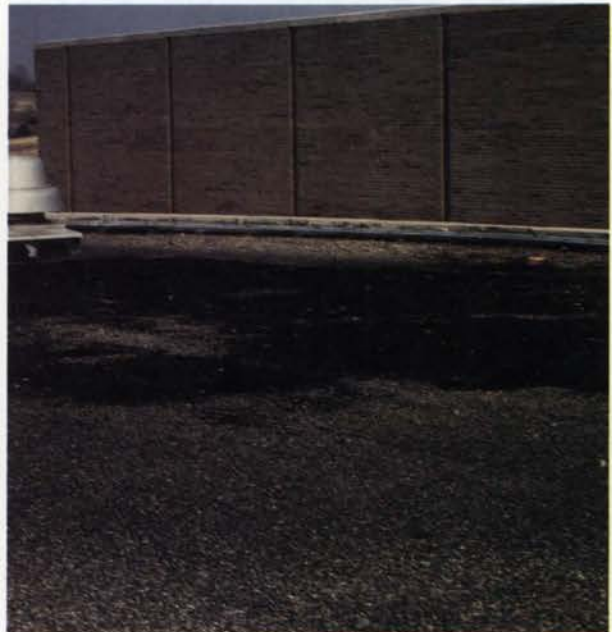
PD10 Ponding  
 <Low Severity>  
 Evidence of ponding shown in PD9

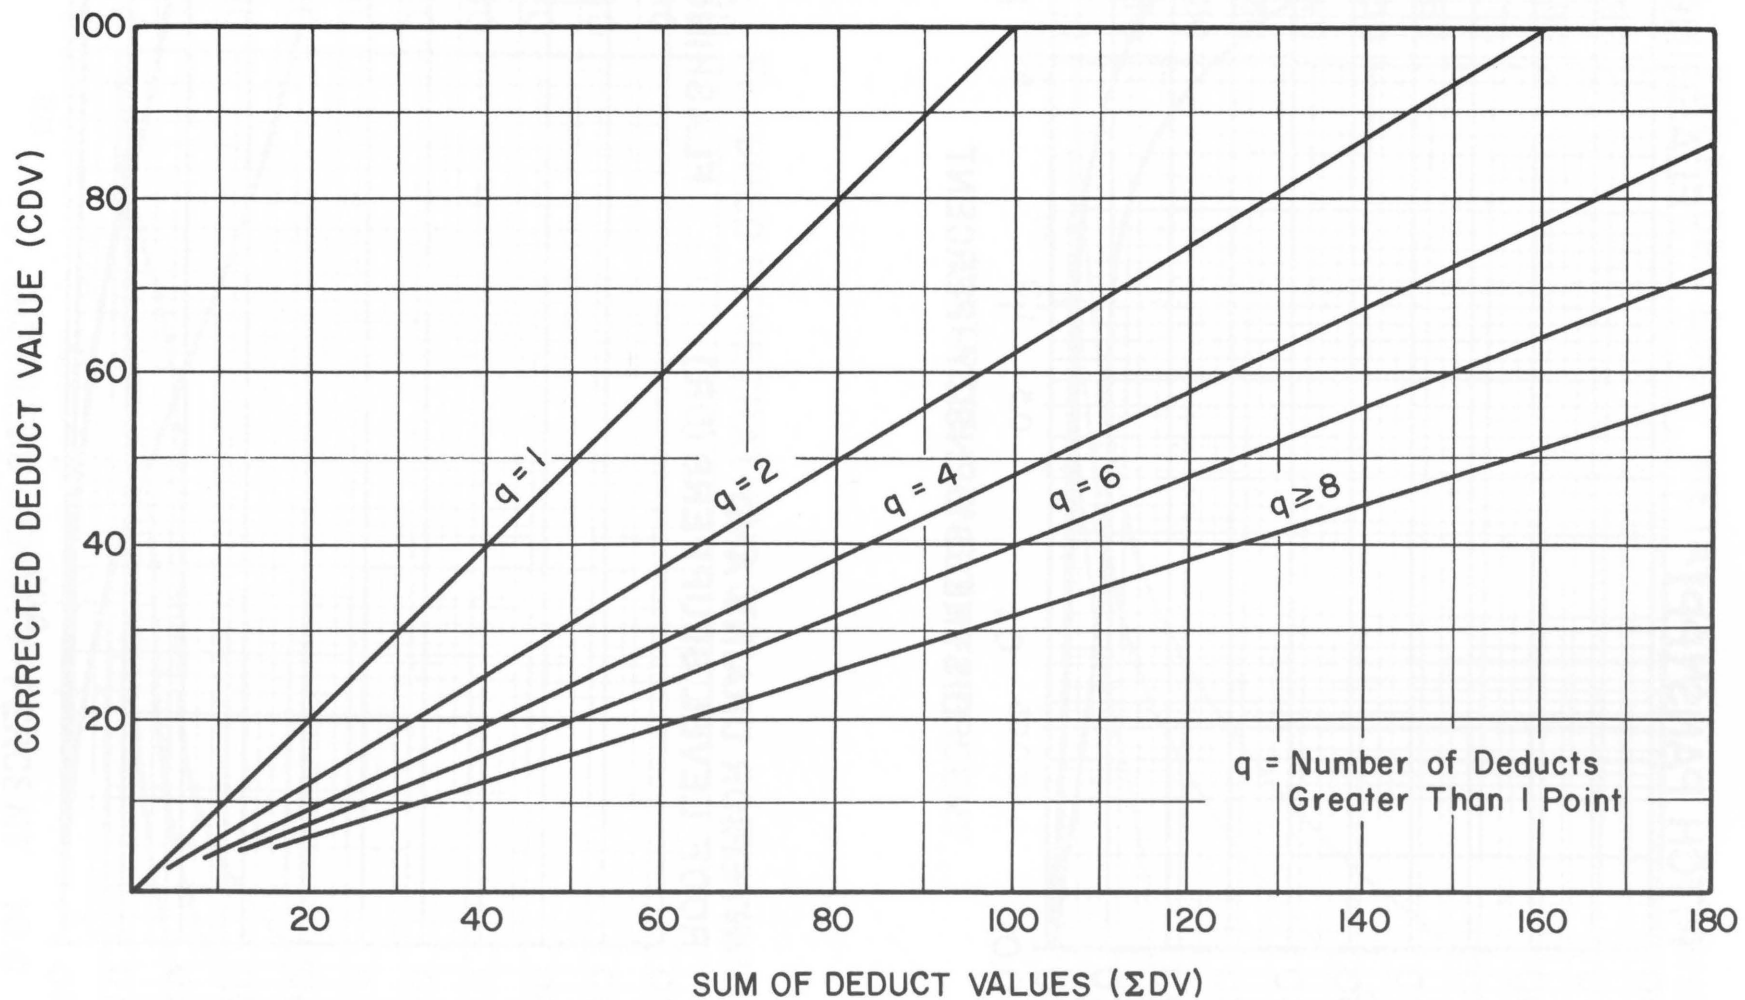
Corrected deduct values for flashing.
